Manhole Inspection Summary

Manhole # S33Q__012MH

Insp Date: **3/14/08 8:49 AM**

Location Address: **1100 leadenhall**

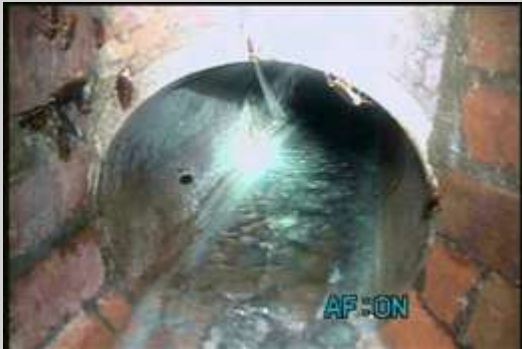
12 O'Clock Outflow

8 in. Circular Gravity Sewer
Pipe Out @ 12 O'Clock

Pipe Material: **Clay** ☐ Pipe Lined

Invert Depth: **10.70** (ft.) Flow Characteristics: **Slow**

Deposits: ☒ None ☐ Mud ☐ Sludge ☐ **Debris** ☐ Grease

Infiltration: **None** Pipe Seal Cond: **Unknown**

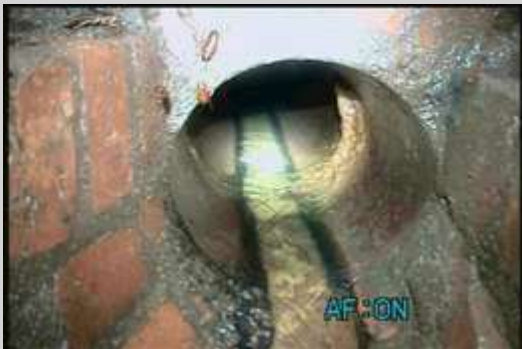
3 O'Clock Inflow

8 in. Circular Gravity Sewer
Pipe In @ 3 O'Clock

Pipe Material: **Clay** ☐ Pipe Lined

Infiltration: **None** Pipe Seal Cond: **Unknown**
